WILLIAMS
ARCHITECTS

FACILITY CONDITIONS ASSESSMENT

16 JANUARY 2026

Grand Ledge Area Emergency Services Authority
500 N Clinton Street, Grand Ledge, MI 48837
(517) 627-1157

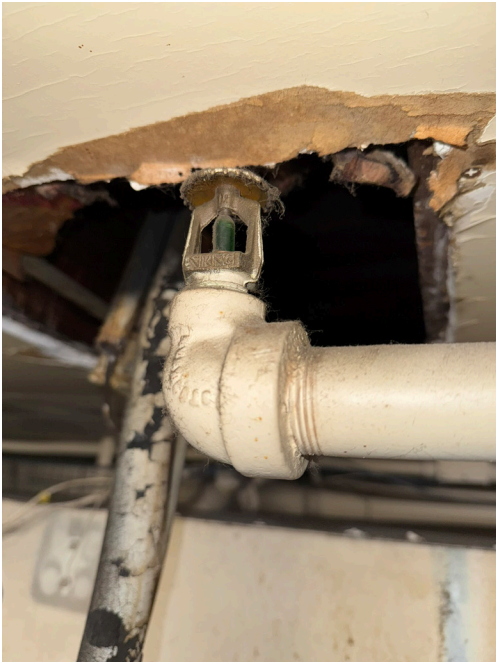
Non-functioning sprinkler system.

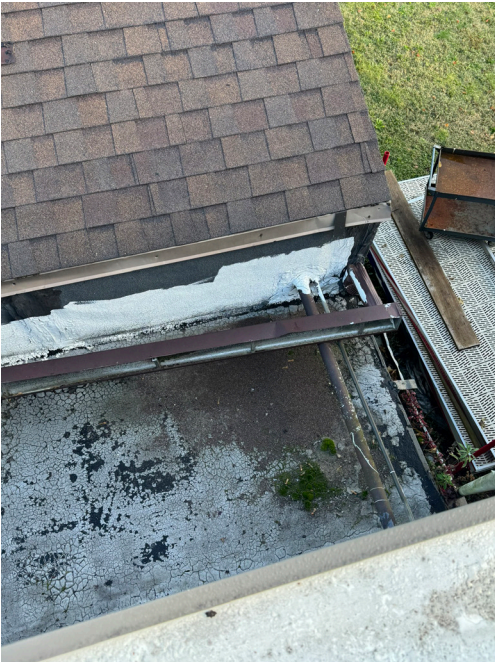
Gutter and downspout pulled away from roof edge. Plant material growing in gutters in need of repair and cleaning. Undersized downspout.

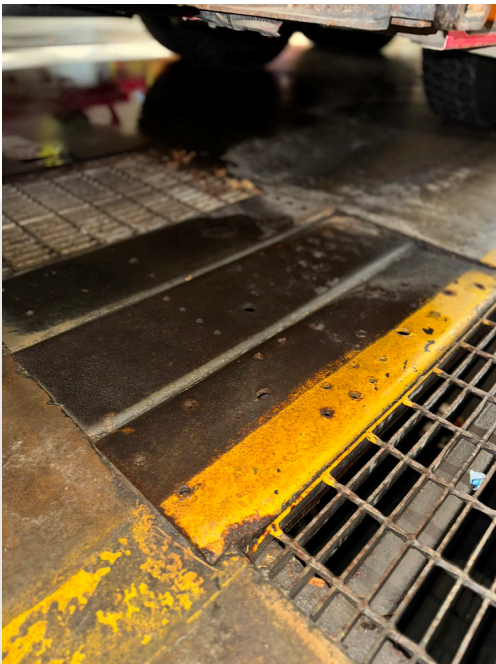
Patched in metal runners over grate at drainage pit is not structurally sound enough to hold the weight of the tanker truck- deflects significantly.

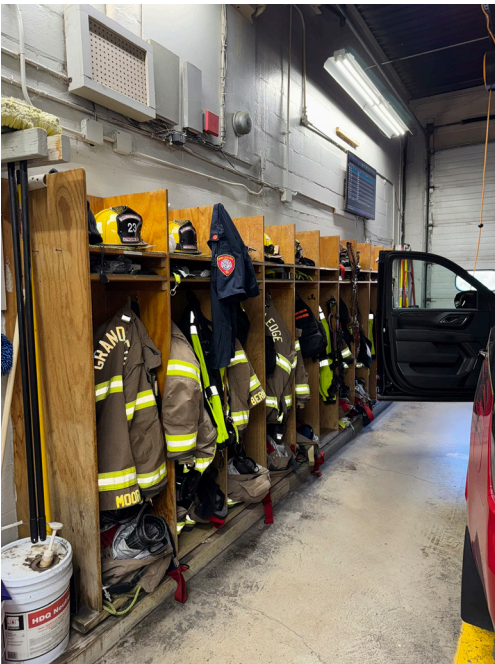
Storage: Clean PPE is stored separately from dirty gear, but this is directly within the apparatus bay, and in plywood (porous material) cubbies that can hold onto contamination.

- **Storage:** Clean PPE is stored separately from dirty gear, but this is directly within the apparatus bay, and in plywood (porous material) cubbies that can hold onto contamination.

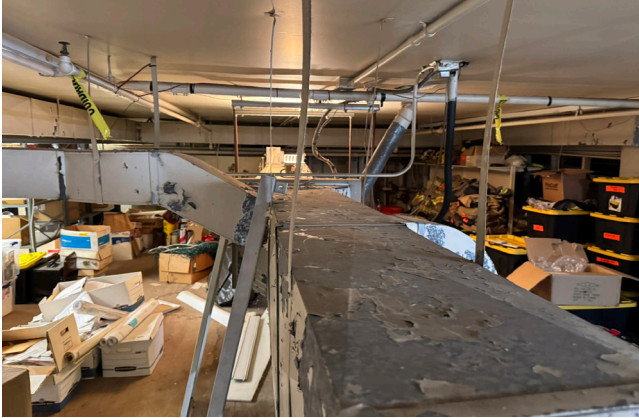
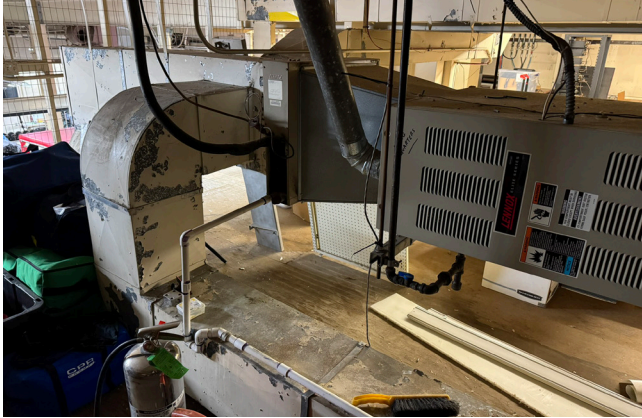
Current HVAC units: Peeling paint on ductwork; Storage of gear and flammable paperwork near gas fired appliances in mechanical equipment mezzanine.

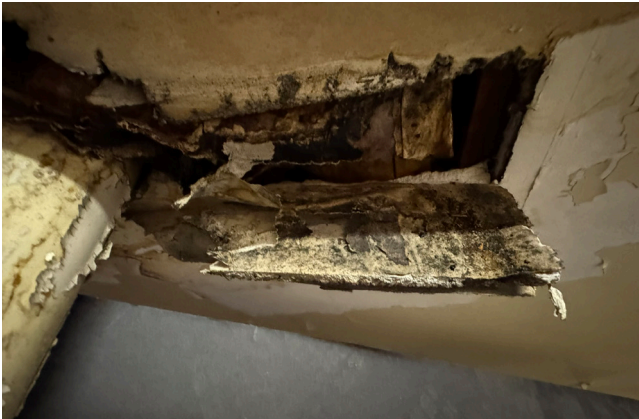
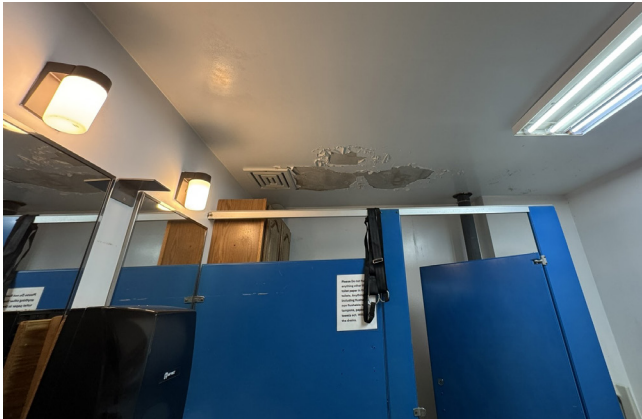
Drywall damage and some partial repairs from prior roof leaks.

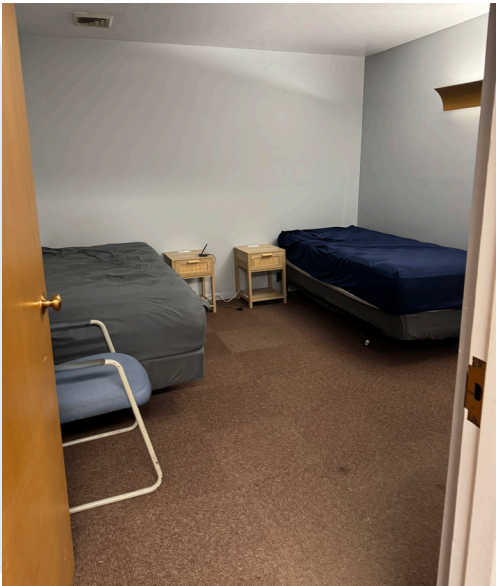
Egress path through sleeping room.
