Grand Ledge Area Emergency Services Authority

Community Forum

Facility Assessment

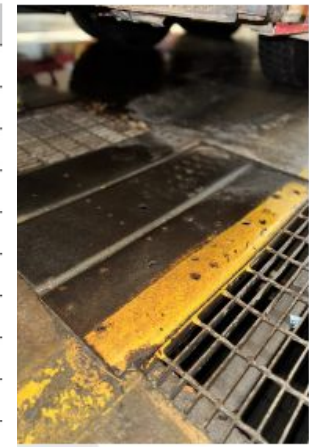
Patched in metal runners over grate at drainage pit is not structurally sound enough to hold the weight of the tanker truck- deflects significantly.

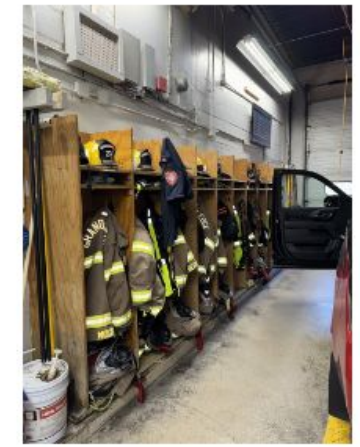
Storage: Clean PPE is stored separately from dirty gear, but this again is directly within the apparatus bay, and in plywood (porous material) cubbies that can hold onto contamination.

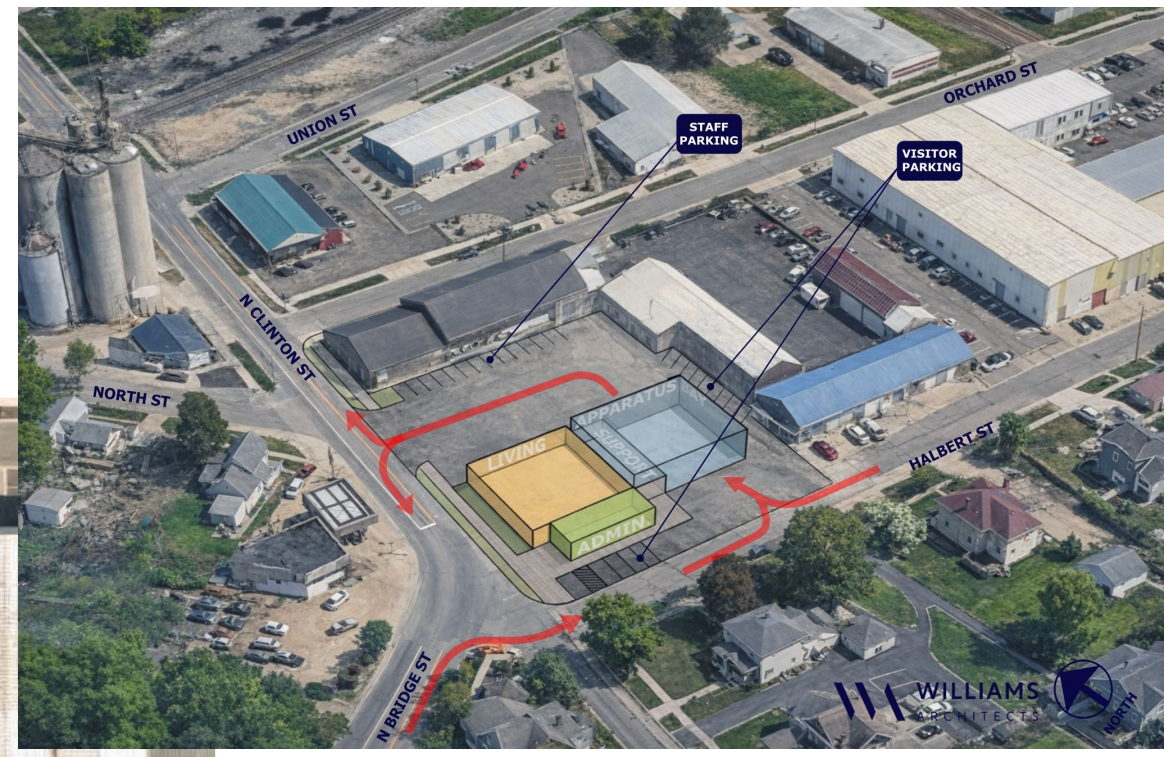
1 PLAN SITE PLAN - NEW SATELLITE STATION LAYOUT
SCALE: 1" = 50'-0"

Site Plan Concept: Satellite Station on Clinton Street
